Manhole Inspection Summary

Manhole # S45W__009MH

Location Address: **1700 Beason Street**

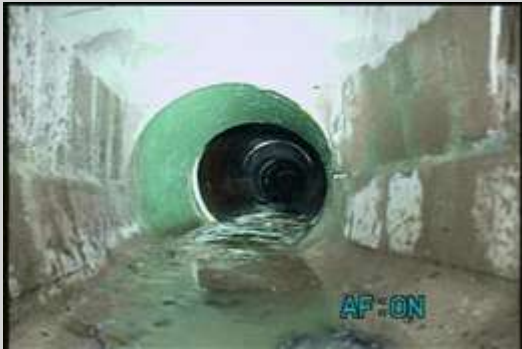
12 O'Clock Outflow

8 in. Circular Gravity Sewer
Pipe Out @ 12 O'Clock

Pipe Material: **PVC** ☐ Pipe Lined

Invert Depth: **8.25** (ft.) Flow Characteristics: **None**

Deposits: ☒ None ☐ Mud ☐ Sludge ☐ Debris ☐ Grease

Infiltration: **None**

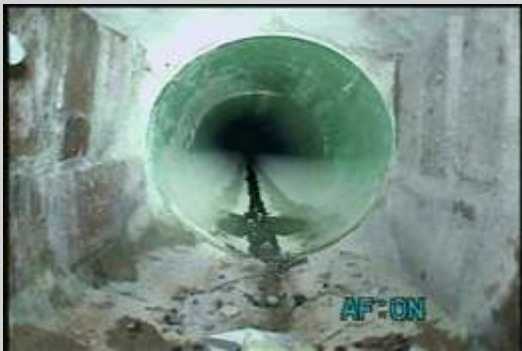
6 O'Clock Inflow

8 in. Circular Gravity Sewer
Pipe In @ 6 O'Clock

Pipe Material: **PVC** ☐ Pipe Lined

Invert Depth: **8.16** (ft.) Flow Characteristics: **None**

Deposits: ☒ None ☐ Mud ☐ Sludge ☐ Debris ☐ Grease

Infiltration: **None**
